Advisory Visit
Exning New River, Suffolk
January 2020

Rob Mungovan
rmungovan@wildtrout.org

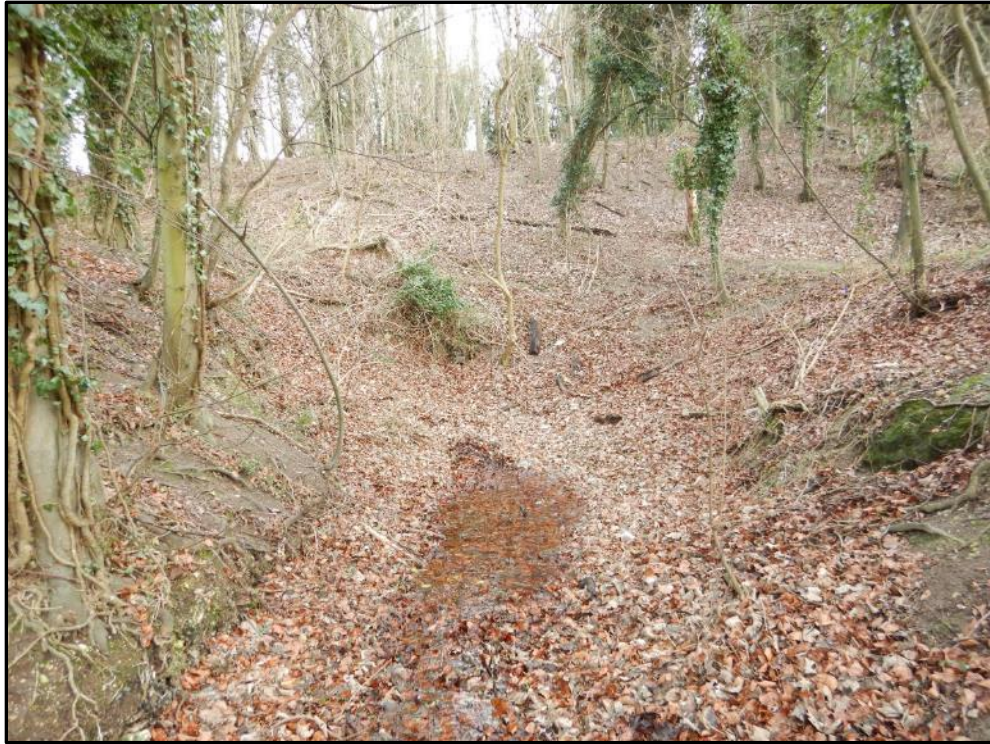
The visit started at one of the upper set of springs. The springhead was damp but not flowing. Inspection of the leaf litter revealed an absence of *Gammarus* sp. shrimp and cased-caddis. It is likely that the springhead ran dry during the recent drought resulting in the loss of some invertebrate groups, and only since the rainfall of October 2019 has water returned to the upper reaches of the river. The Newmarket area is known to be one of the driest areas in the country. With low recharge rates, and an increasing demand for water from ground water abstraction, the return of natural flow to the New River is unlikely given the present situation.

Pic 1 – One of the springheads of the river, the damp ground was not flowing.

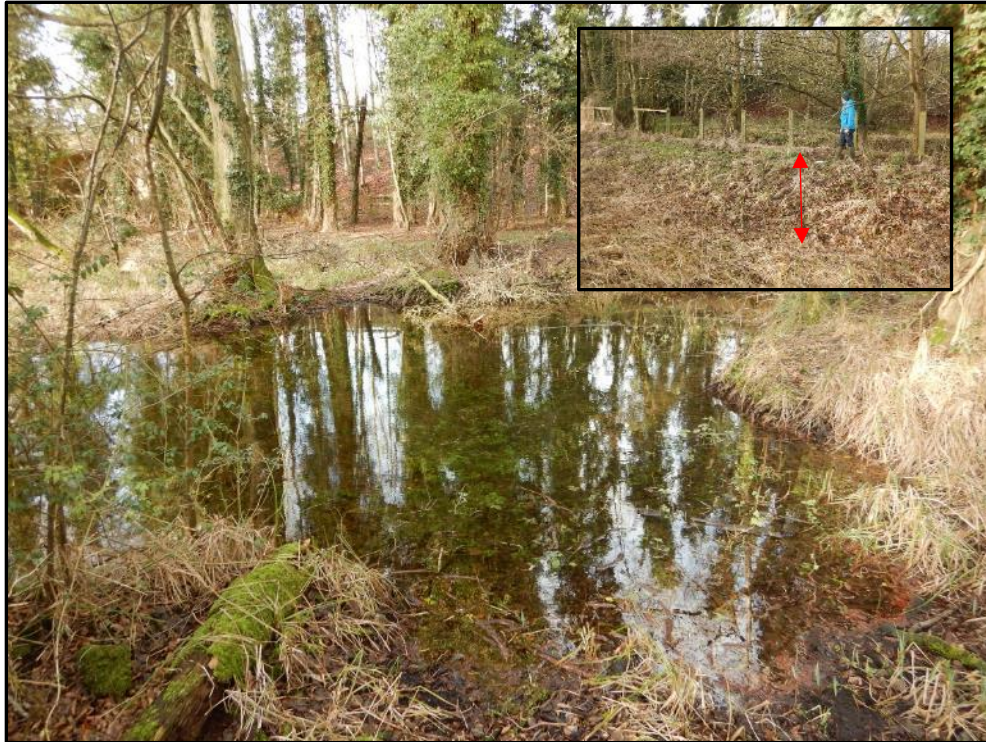
After emerging from the springhead, the river flows through an ecologically interesting area of wet woodland. Common alder trees grew in partially submerged conditions with ash on the drier ground. Many of the trees were unmanaged giving the area a wild feel (pic 2). The river was partially shaded, where the canopy broke, lesser pond sedge and lesser water parsnip were present. No intervention is recommended in this area, as the value of the wet woodland as a whole is more important than the river itself, to undertake work to improve flow within the channel is considered to be cost-prohibitive. It was apparent that the river had been dredged in the past as a levee prevented water from spilling out on to an adjacent meadow (pic 2, inset pic). If the catchment were wetter, it might be worth investigating reconnecting the river to its historical floodplain, however the adjacent meadow showed no signs of water-logging and there is a significant risk that any rewetting of the floodplain might further diminish flow in the river. A representative from the Jockey Club was present for this reach of the visit, he was able to confirm that no management takes place at this location and that it is unlikely to happen in the future.

Pic 2 – The river flows through an ecologically valuable area of wet woodland. Inset pic shows a levee (red arrow) adjacent to the river.

No interventions are recommended in the area upstream of the A14 in the wet woodland. That area should be left undisturbed as a haven for its flora and fauna (especially invertebrates).

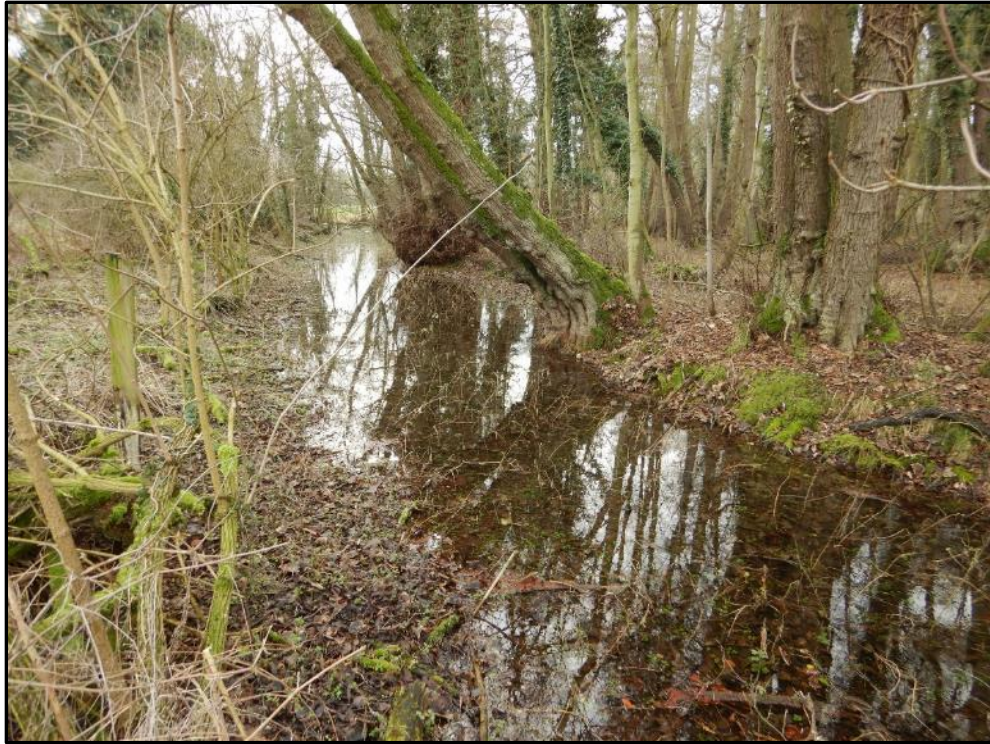
The lack of flow, combined with a low gradient, affects the river's ability to transport fine sediment. Consequently, the river has become over-laden with silt and organic matter. Fine sediment has a negative impact upon a river's invertebrate production by reducing the number and diversity of niches available within the gravel bed. Importantly, trout need clean and stable gravel (particularly in the size range 10-40mm) to spawn upon. With their eggs remaining in the gravel for up to 100 days before completing incubation and development from alevins to fry, trout eggs are very susceptible to mortality from siltation or physical disturbance.

The problem of siltation is further compounded by the river having been canalised (the process of cutting a specific channel to create a defined channel, as opposed to a collection of small streams and seepages that may have once flowed across the landscape) at some point in its history. Diminishing flow in an over-wide artificial channel restricts the river's ability to transport fine sediment. The river is becoming a settling pond for fine sediment with no ability to deposit it upon its floodplain.

Pic 3 – The river shows little ability to transport fine sediment, consequently it is prone to excessive silt loading.

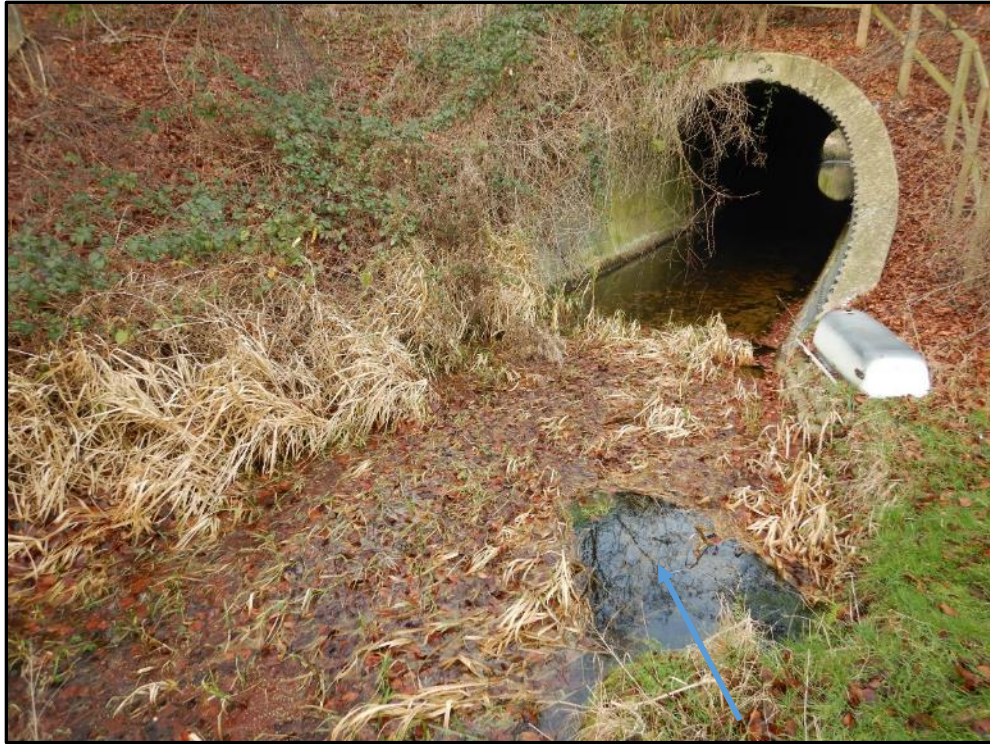
The location of the EA's groundwater support borehole was observed, with the water discharging and creating a local area of high energy flow which quickly dissipated. Immediately downstream of the outfall the river had a slight increase in plant diversity with willow moss present amongst reed sweetgrass and occasional great willow herb in the margins. There were patches of clean gravel and it was reported that small fish (most probably a stickleback species) were seen in the summer. The bed had firm gravel and occasional larger stones. Stones were turned to assess the general health of the river. Sadly, no *Gammarus* sp. shrimp were seen, no bullhead fish found, and the stones were mainly sheltering flatworms and hog louse; both are groups that can tolerate low oxygen levels and high organic loading.

Pic 4 – The EA's groundwater support outfall (blue arrow) and the culvert beneath the A14.

The river flows beneath the A14 in a wide corrugated metal culvert sunk beneath the riverbed which has been backfilled with gravel. A short way into the culvert, the river was silting up due to its overwide form. Ironically, it is possible that the over-deep nature of the culvert acts as a pond habitat, with shading to maintain cooler water temperature, thus enabling small fish to survive when the EA's pump occasionally fails.

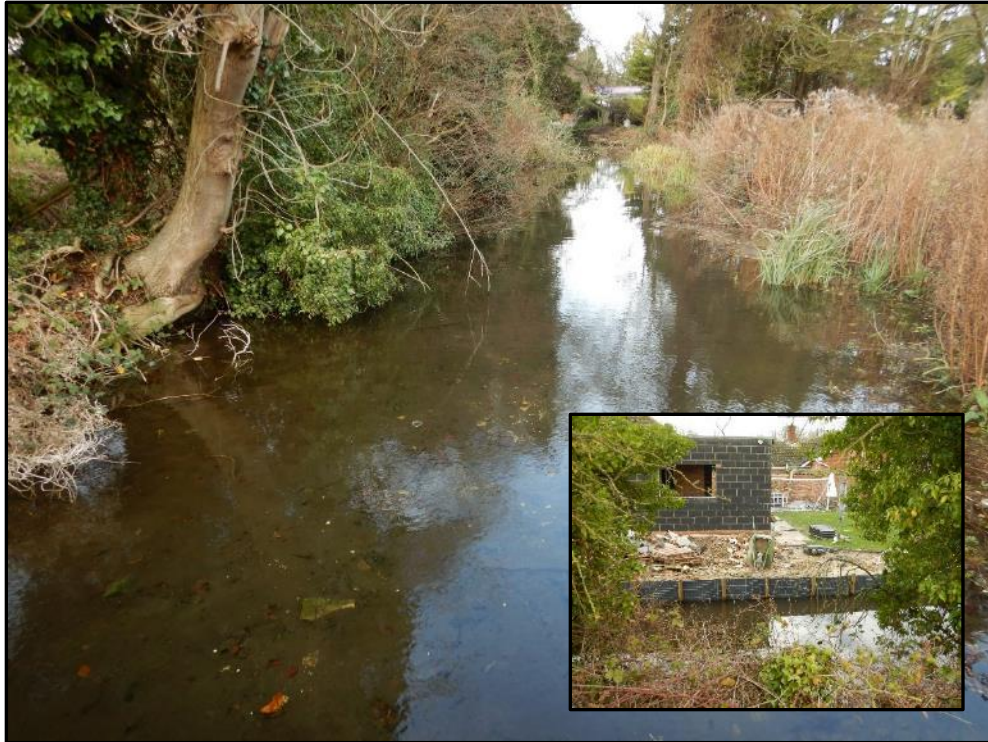
The gardens have used various means to strengthen their banks from concrete, through to modern plastic membranes (see pic 5 inset). The river was over-wide with a very slow velocity. The river contained a very high volume of fine silt with no gravel seen. The smothering of the bed by dense silt, a very low velocity flow and no clean gravel bed for spawning upon makes this reach and those above it completely unsuitable for brown trout. The impounded flow only compounds the problem.

Pic 5 – The river downstream of the A14 is overwide and impounded. Where gardens back-on to the river hard bank revetments are the usual inappropriate means of bank treatment.

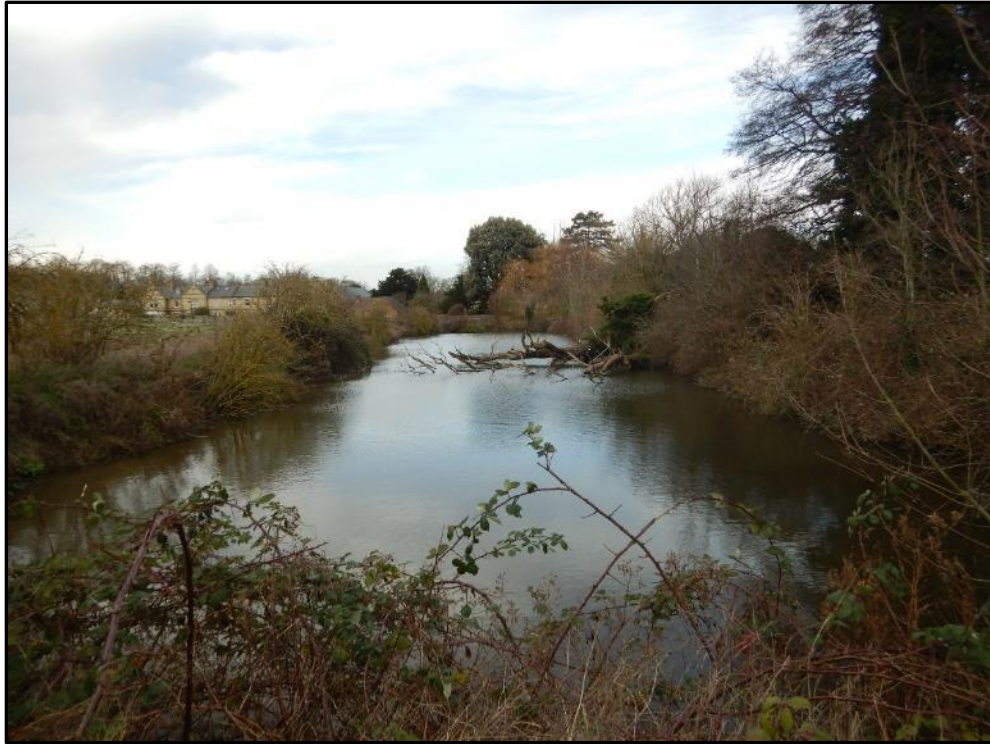
Adjacent to the river is an historic fishpond. The pond has been thoroughly cleaned out in recent years with dredged material placed around the pond forming bunds. It was important to note that the pond was drawing water from the river, but did not appear to have an outfall back to the river. Thus, the pond represents a leak point for the river. Whilst the proportion of flow lost to the pond might appear insignificant every drop of the groundwater support is required in the river unless the pond is deemed more ecologically valuable (such as sustaining water voles) than the stream. Whilst the pond has historical interest, and was reported to never dry up, on the day of the visit it did not appear to have any great ecological value. There were no aquatic plants and very limited marginal flora. It is highly probable that the pond acts as a habitat for the river's duck population and it is their constant feeding and dabbling that has restricted plant growth and led to the pond's turbid appearance. Also of note was the occurrence of a disused crayfish trap. If signal crayfish are present then the pond may be acting as a reserve habitat for them, aiding their survival through dry periods. The crayfish will be causing degradation of the pond's environment and will cause disruption of the river's ecosystem if their population establishes high numbers within the river.

Pic 6 – The fishpond which draws water from the river.

The fishpond is drawing water from the river. The river has a limited amount of water and the volume lost to the pond, and to increased evaporation, is likely to be detrimental to the river's flow. Based on the pond's ecological

value, judgement should be made as to whether the pond should still receive the flow.

The pond may contain signal crayfish as a disused crayfish trap was found. If the pond indeed contains the invasive non-native crayfish then that is a further reason to isolate it from the river. Surveys should be undertaken to establish the extent of crayfish in the New River.

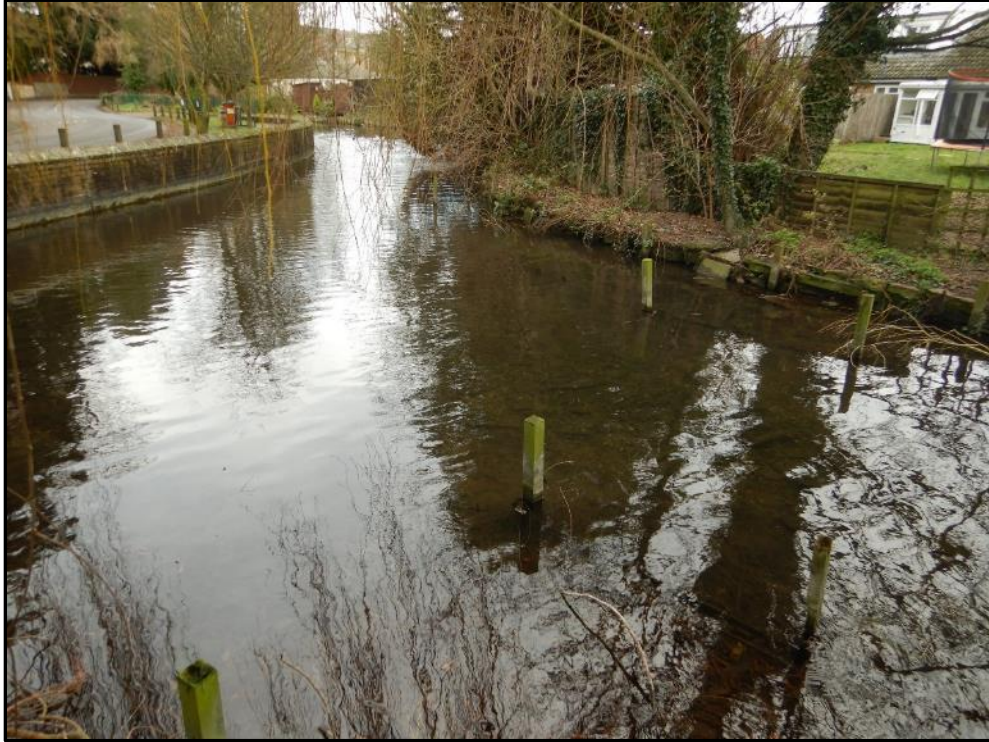
At Ducks Lane the river has been widened to form a duck pond, and is impounded by the road bridge (with a width $\sim 1.2\text{m}$). Past habitat improvement work had seen a small naturalistic concrete weir created to retain more water. Channel narrowing has also been undertaken at the inflow to the pond, but that work has now degraded due to ducks and shading affecting plant growth required to stabilise the structures. The previous channel narrowing is ineffective due to the impounded and diminished flow not providing the water velocity and scour that was desired.

Pic 7 – The river has been widened in the village to form the duck pond (of Ducks Lane).

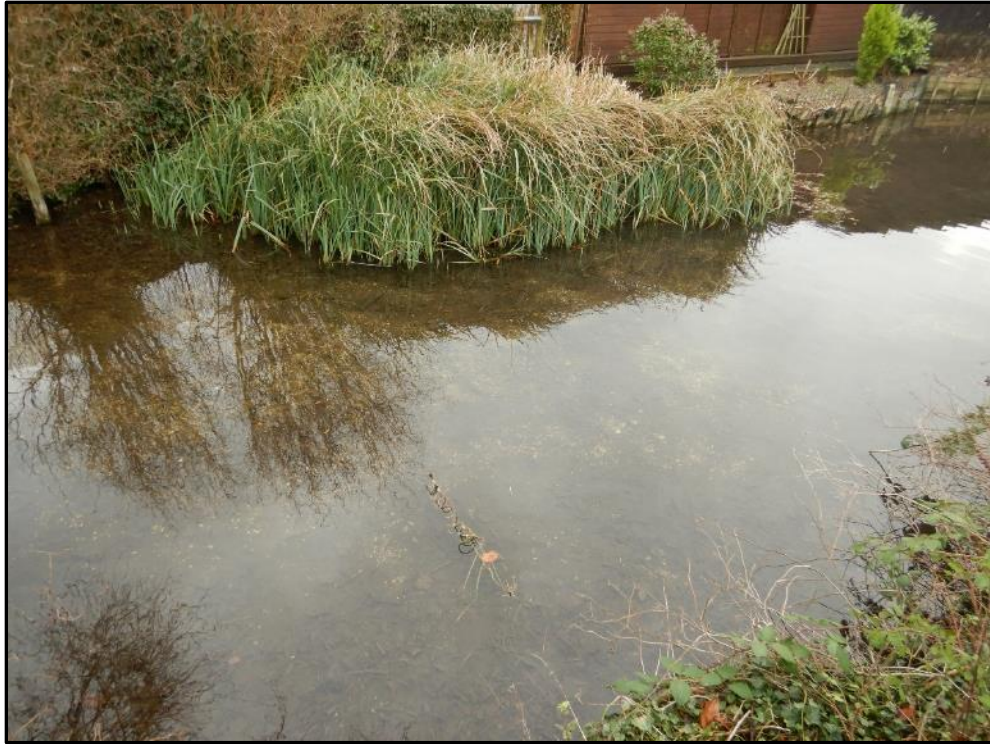
The pond has limited stands of marginal vegetation. Of most ecological value is a large stand of lesser pond sedge. A water vole was seen, and it is probable that it had created a nest within it or had found an area of unprotected bank to burrow into.

Pic 8 – The stand of lesser pond sedge which represents important habitat for water voles in an otherwise sparse environment.

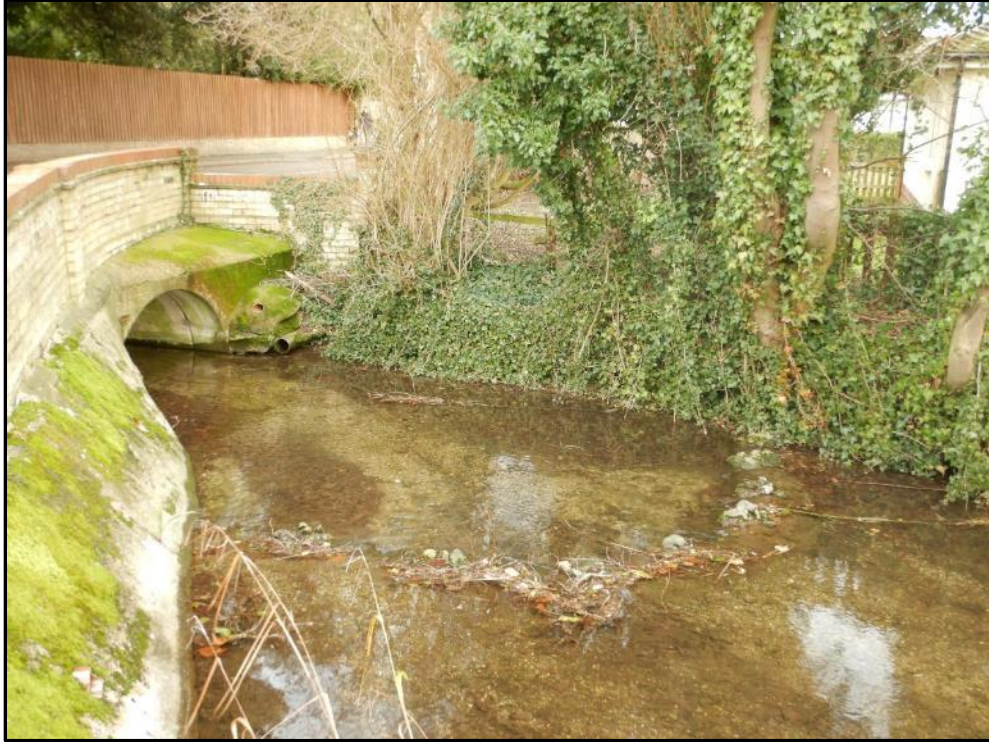
An objective of the visit was to conceive a habitat enhancement project for the Ducks Lane area. However, several important issues need to be considered. The river's flow is now intermittent and much reduced, thus to initiate the bed scour intended by narrowing down the river, even further narrowing would be required than was done previously. But it is unlikely that narrowing would produce the desired results due to the pond's impounded flow. Removal of the impounding weir would increase water velocity, but it is unlikely to be very significant due to the impounding effect of the road bridge, And, if the weir is removed the consequential loss of water level in the pond would result in the ducks causing greater disturbance to the riverbed as their dabbling would reach more plants and their feet would constantly mobilise fine sediment in the shallow water. Loss of the duck pond is very likely to cause upset in the village and turn people off from river conservation if they perceive it as leading to the loss of a cherished village feature. The underlying problem is one of lack of river flow and gradient, which in turn reduces bed scour and limits fine sediment transport.

Pic 9 – The road bridge of Ducks Lane holds water back within the pond, and a concrete and stone weir has been constructed to retain a greater head of water.

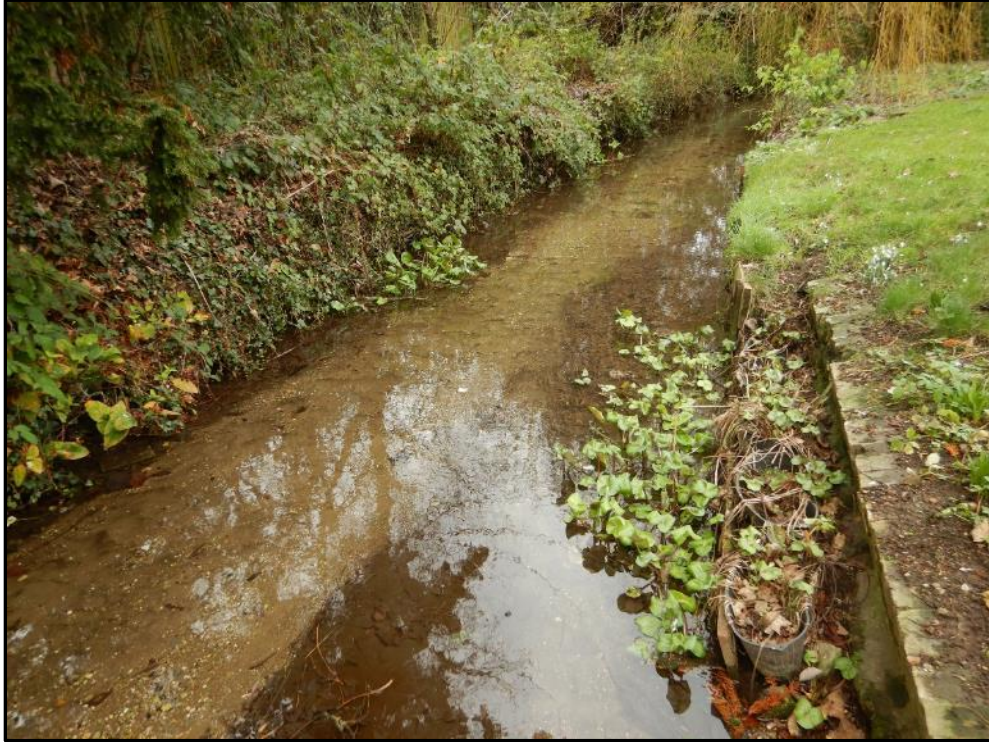
After the impounding road bridge of Duck Lane, the river ran with a degree of gradient and consequently the bed was cleansed of the fine organic sediment and showed the chalk bed (albeit generally dominated by fine chalk particles). The river was ~2m wide and ~0.1m deep. The only marginal plants were marsh marigold. This reach may also be impacted by the ducks and/or affected by shade. Nevertheless, the increased water velocity might just be enough to sustain water crowfoot if it was introduced. Water crowfoot provides important physical structure for retaining a head of water, creating flow diversity, increasing cover, as well as habitat and food for numerous invertebrate species. The plant is typical of clean, swift-flowing rivers.

Pic 10 – At the Old Rectory the river ran relatively swiftly and showed a bed of chalk particles.

If the flow is not enough to sustain water crowfoot then consideration should be given to introducing other aquatic plant species such as starwort, water milfoil or possibly curled pond weed. It is certainly better to have some aquatic plants than none. The impact of duck grazing upon the plants should be assessed.

Where the river had flow it may be possible to establish water crowfoot by planting it out in the riverbed (in early spring). Plants could be taken from the river lower down (with landowner permission) where it grows profusely. Information on how to plant out crowfoot can be found at <https://www.wildtrout.org/wttblog/sprite-method-re-establishing-ranunculus-post-industrial-rivers>

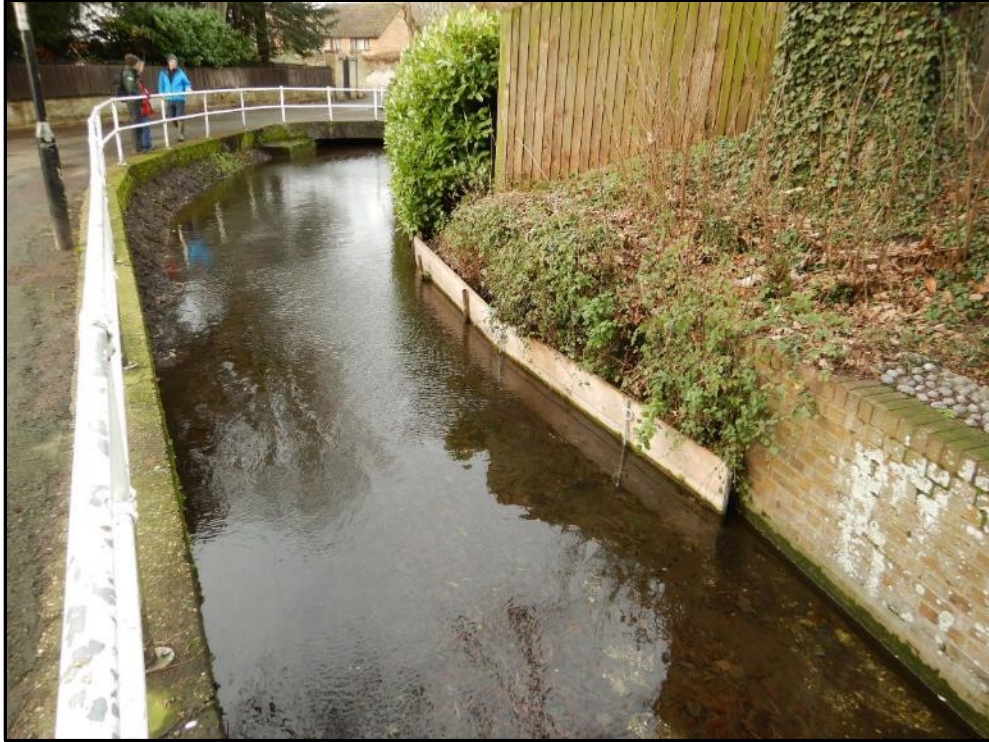
The river was viewed upstream of Church Lane, its gradient had been lost and it was filling with fine organic silt again. It was interesting to note the small width of the culvert (~1m wide) running beneath the road. The small size suggests that the river has never been prone to flooding (none were known for the village) and/or that the flow of the river has never been very large.

Pic 11 – The river in Church Lane had no habitat to sustain trout nor water voles. Note the recently installed toe-boards.

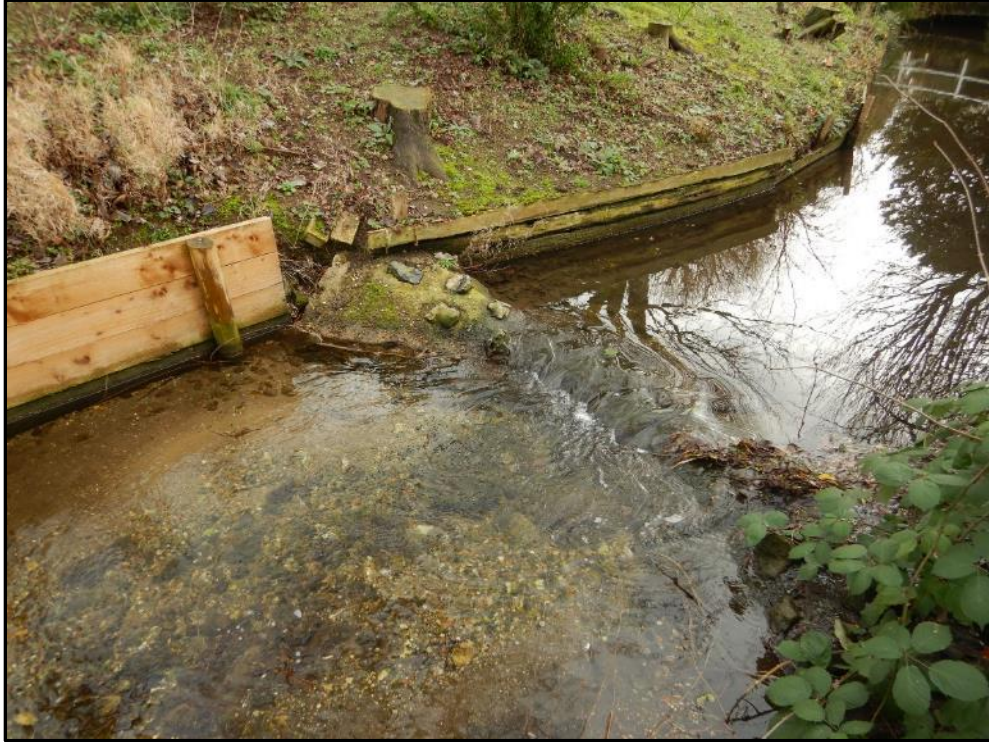
The cause of the build-up of silt at the Church Lane bridge is a weir immediately downstream of the Brookside road junction. The weir retains a head of water $\sim 0.15\text{m}$ but it has impounded flow for $\sim 80\text{m}$.

Pic 12 – A further weir is present at the end of Church Lane.

Weirs are degrading the riverine environment and should be removed. This is likely to be contentious with some landowners, it is therefore recommended that the weir near Brookside be the first for removal. Its impact on the reach above can be easily assessed without the need to go on to private land. If more reaches of the river can be re-energised then it may be possible to establish areas in which to plant out water crowfoot.

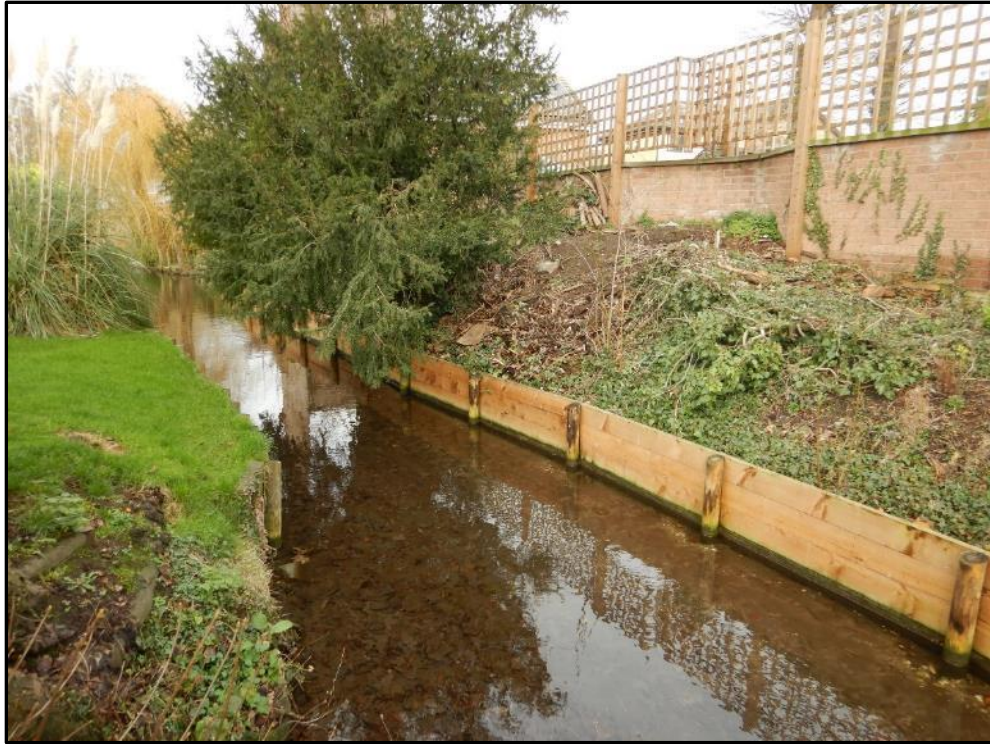
As the river flowed downstream of Brookside towards New River Green it formed a boundary to many residential properties. Sadly, all properties have protected their banks using hard engineering approaches (wooden toe-boards, stone-filled gabion cages and even brick and paving stone combinations). For such a low-energy river these approaches are vastly over-strengthening the banks. More importantly the works have totally disconnected the river from its riparian environment, there was no graduation from land to water, which makes it hard for marginal plants to find their niche. The presence of marginal plants along a watercourse is crucial; plants provide cover and food for a wide range of invertebrates which in turn sustain birds, mammals and fish. Plant roots within a riverbank bind soil particle aiding bank strength, controlling fine sediment input and adding hugely to the natural beauty of the river corridor.

Pic 13 – The river after Church Lane, the channel is devoid of any plants, the left bank is supported by gabions and the right bank by new toe-boards. Both means of bank stabilisation degrade the river.

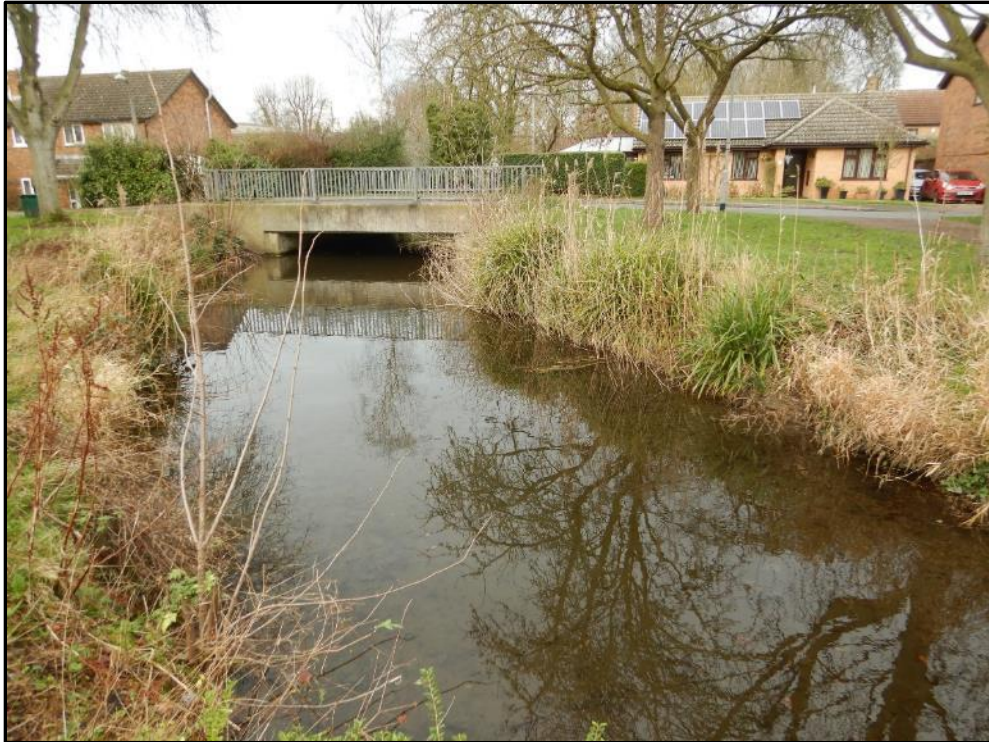
Immediately before New River Green bridge the river has been widened to create another pond-like area. It was reported that until recently it contained an island which had been planted with common reed. The common reed had become too dominant for the narrow river and it was dredged out by Suffolk County Council. The over-wide channel is now silting up again. Fortunately, the banks remain in a natural state and supported some of the densest marginal growth on the river. It is very probable that water voles reside in this area.

Pic 14 – The river at New River Green. The natural vegetated banks are likely to provide important water vole habitat and must be retained.

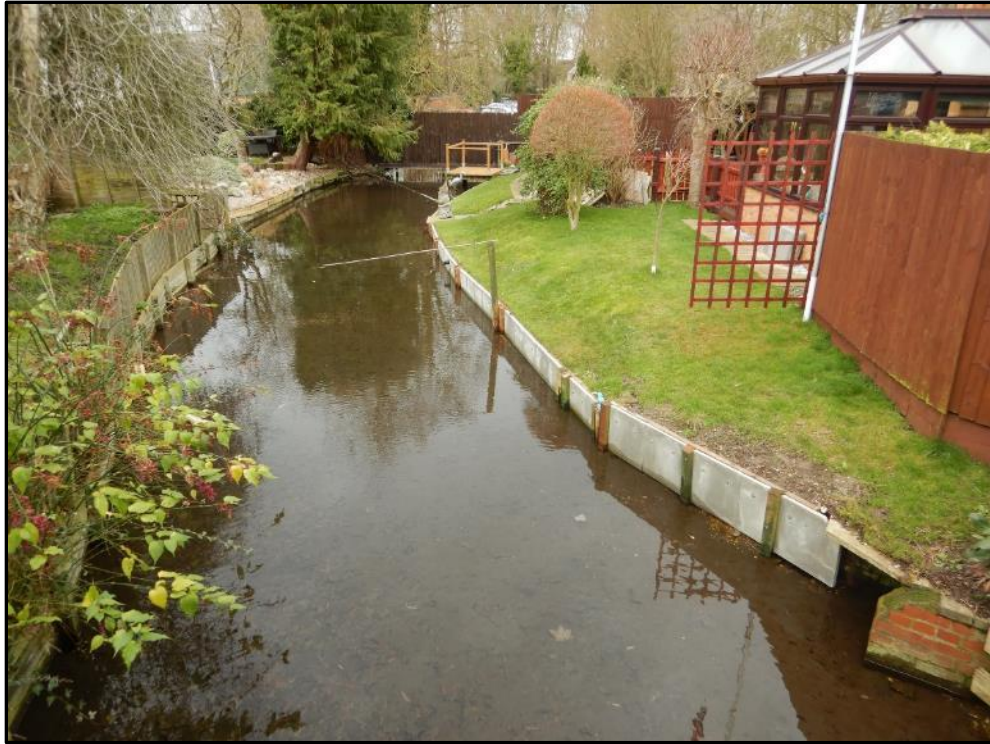
The river downstream of New River Green has the appearance of a long shallow pond. Unfortunately, the in-river habitat is very poor and marginal habitat has been lost to insensitive bank protection. It was interesting to note that kingfisher perches had been erected so one can assume that residents enjoy some of the visiting wildlife. Kingfishers would be more frequent visitors if the river's habitat was more diverse and the flow not impounded.

Pic 15 – The river downstream of New River Green.

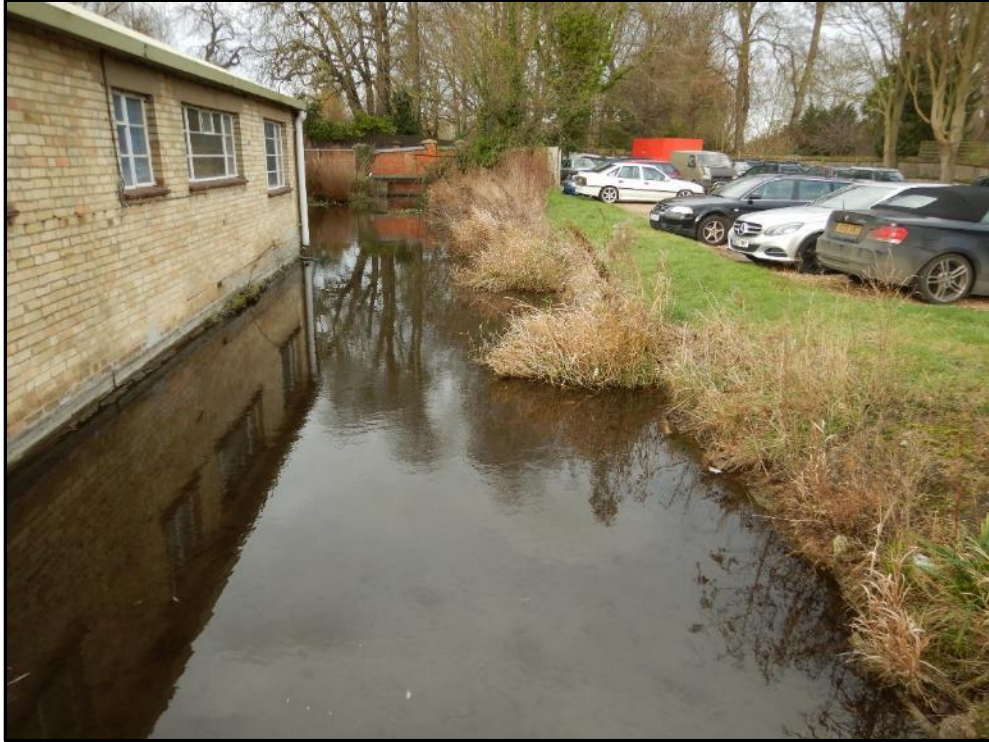
Moving downstream, the river was accessed via a small industrial estate off Swan Lane. Although the river had a building upon its LB, natural banks were retained elsewhere and provided important water vole habitat. With respect to the river itself, it was still vastly overwide at ~6m with an impounded flow. Approximately 4m upstream of the Swan Lane bridge evidence an old water-retaining board was observed. However, it was drowned-out indicating that the current impoundment is from further downstream.

Pic 16 – The river at Swan Lane industrial estate is overwide and impounded but does at least retain areas of vegetated banks.

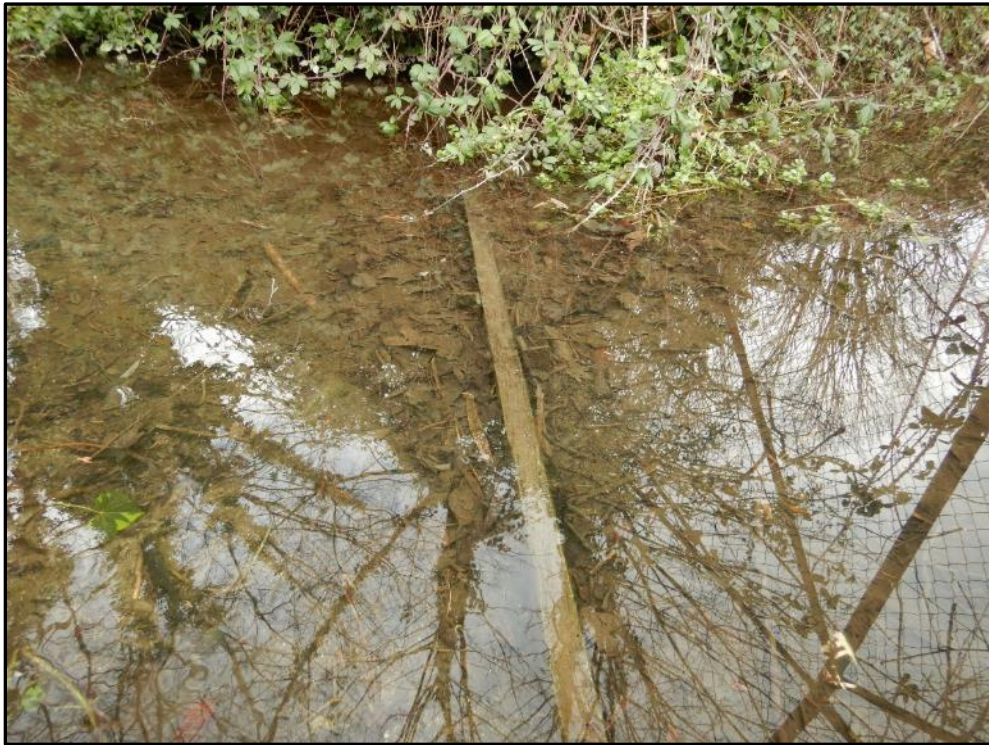
Pic 17 – The previous water-retaining board is now drowned-out by a further impoundment downstream.

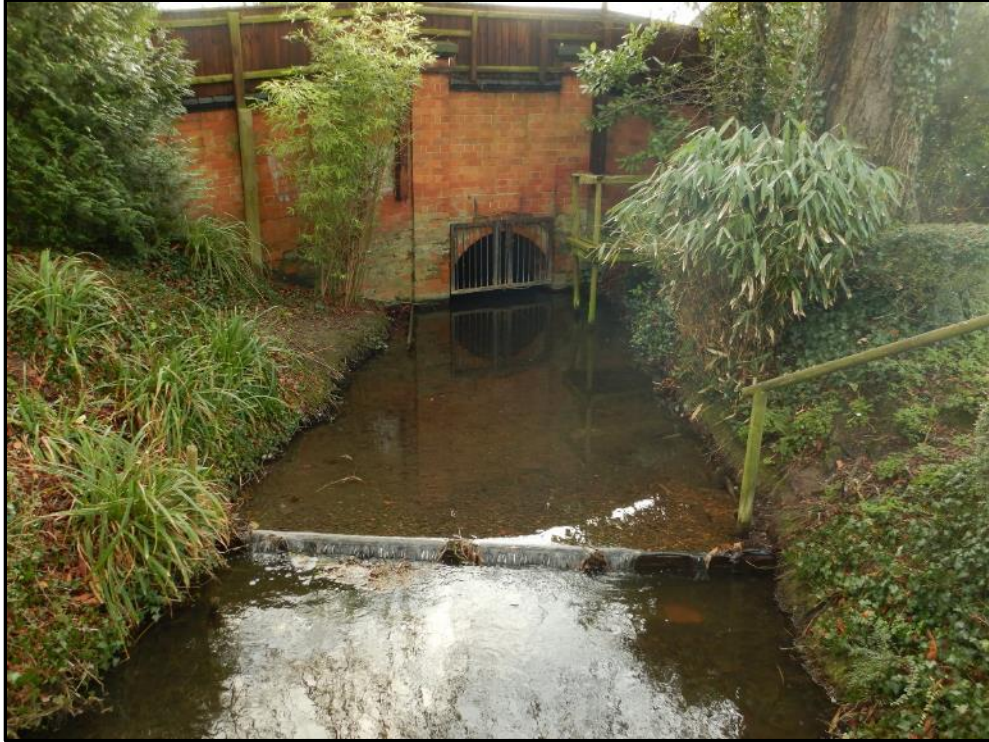
Inspection of the reach found 2 weirs. The first was a short distance downstream of the Swan Lane bridge and retained a head of water $\sim 0.1\text{m}$. It is responsible for the impounded flow at the Swan Lane industrial area.

Pic 19 – This weir is affecting the river for at least 150m upstream to New River Green. It should be removed as it provides no benefit to the property in which it is located.

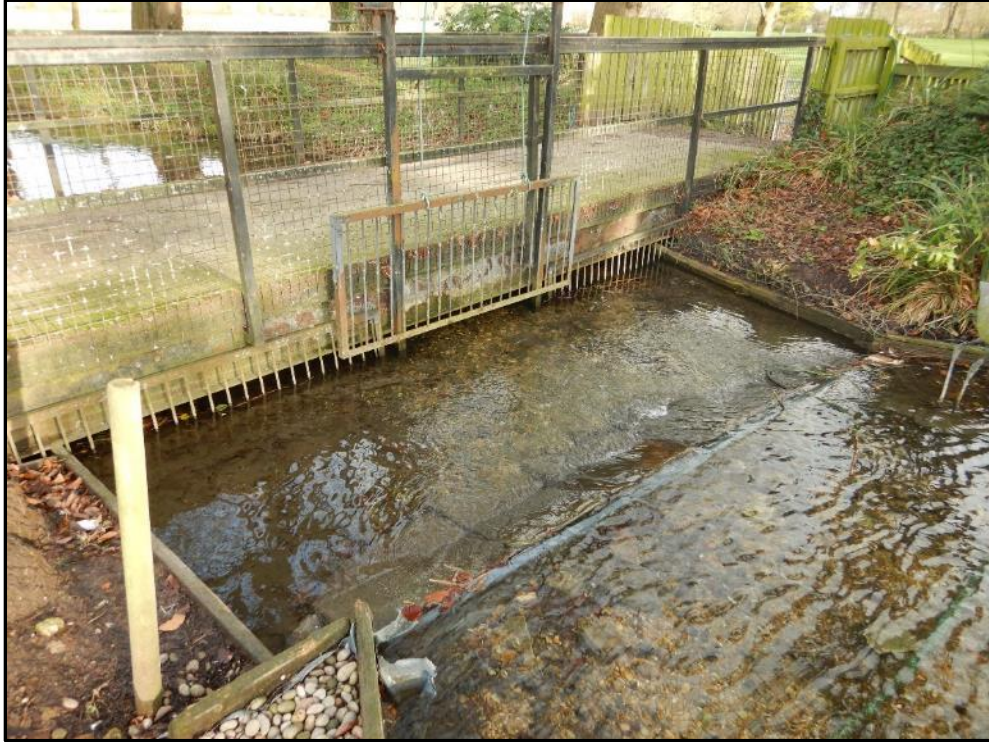
The second weir (pic 20) was more significant and held $\sim 0.2\text{m}$ head of water. It was created to retain water for the owner's wildfowl collection and integrates with a grille across the river (to stop birds, not fish).

The impoundments, in combination with the adjacent trees, their leaf-fall and the dabbling habit of the wildfowl, were retaining a high volume of fine organic silt.

Pic 20 – The weir within the Regal Lodge grounds is used to retain water for a wildfowl collection. It is degrading the river.

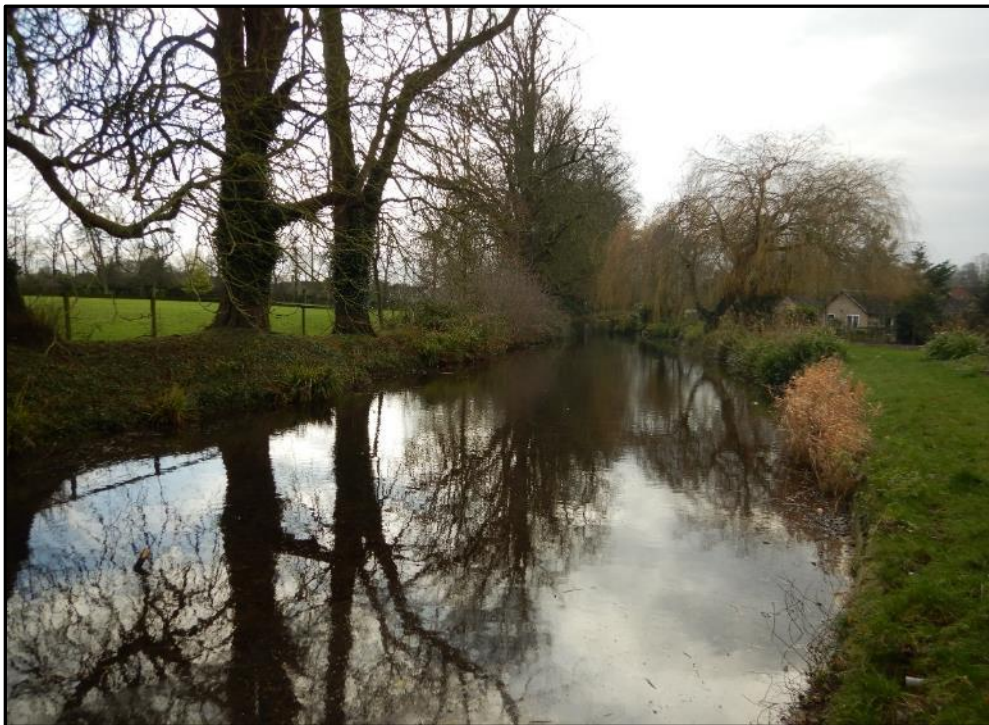
Access was gained to the mill grounds. The mill pond was ~12m wide and almost entirely filled with silt. No attempt was made to test the depth.

Pic 21 – The silted-up mill pond.

The former mill site represents a significant impoundment and silted reach of river. The side-sluice looks to be in a poor state of repair. When it requires rebuilding consideration should be given to creating a sluice gate that extends to the bed to enable the mill pond to be fully drained. This may initiate improved sediment transport but it's unlikely to cleanse the entire reach. NB

– to simply allow large volumes of fine silt to be flushed downstream in one event is unacceptable. Plans will almost certainly be required for specialist desilting of the mill pond at some point in the future.

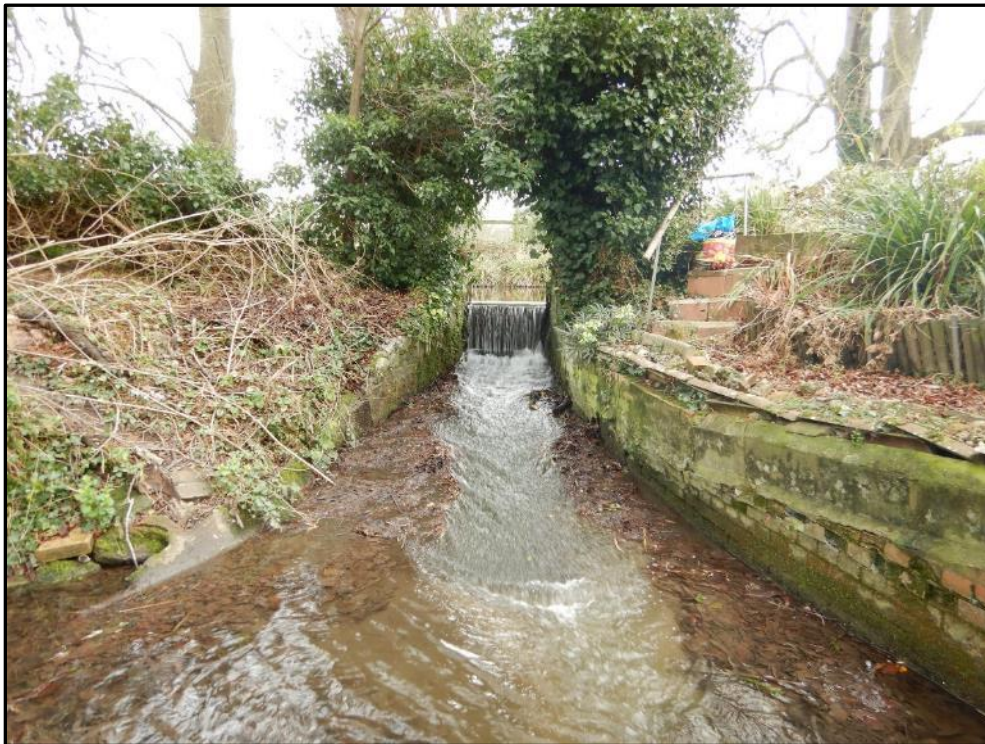
A side-sluiice conveyed the entire river flow away from the mill and down a narrow channel with a drop $\sim 1.2\text{m}$. The sluice is completely impassable to fish. Immediately downstream of the sluice the bed was clean of silt due to the turbulent water. Stones were turned to assess the invertebrate fauna and to search for bullhead. The invertebrates were more diverse than beneath the A14 bridge with *Gammarus* sp. shrimp present, but no bullheads were found. Bullhead have probably been lost from the river through Exning due to its drying, poor habitat and lack of connectivity to its permanently wet lower reaches preventing them (and other fish species) from recolonising.

Pic 22 – The side-sluiice now conveys the entire river flow.

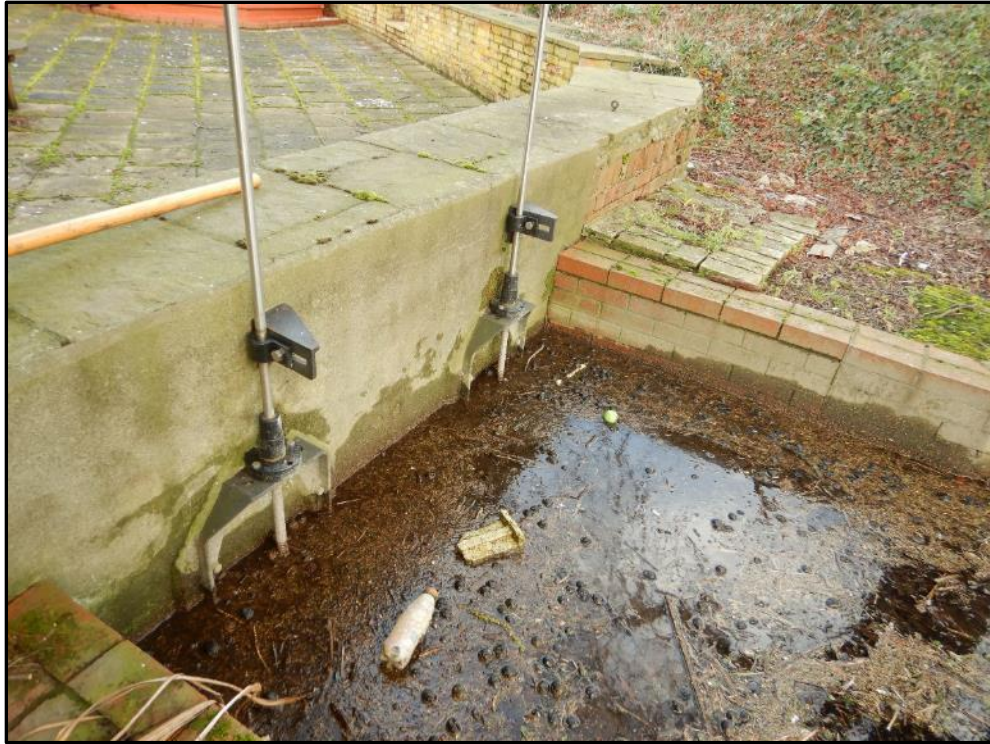
The mill had 2 lifting gates each controlled by a hand-screw arrangement. The apertures of each gate appeared relatively small at $\sim 0.3\text{m}$ diameter and were clearly recent installations to take flow beneath the current house at the site of the former mill. It is not known what the previous arrangement was, but the current set-up is clearly resulting in a lack of flow moving beneath the mill site and a consequential siltation of the mill pond due to almost no sediment transfer. It should be noted that due to the establishment of gardens, additional properties and mature trees, there is no easy means of removing silt from the mill pond and no place to put the silt to allow it to dewater.

Pic 23 – The sluice arrangement at the mill.

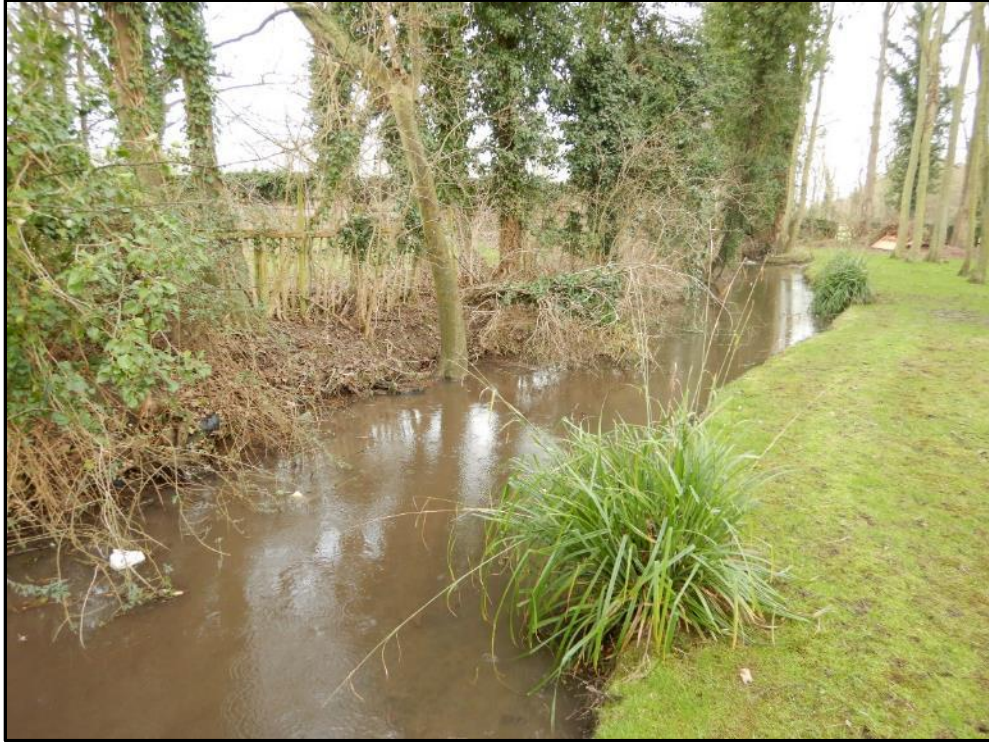
The side-sluice channel was followed. It was ~3m wide with a relatively rapid flow in places. However, it was degraded as a result of past dredging, shading and another weir impounding its flow. There was also a very high volume of leaves dumped on the riverbanks which ultimately will result in nutrient enrichment of the river.

Pic 24 – The side-channel around the mill, it is also impounded and full of silt.
