Advisory Visit
Exning New River, Suffolk
January 2020

Rob Mungovan
rmungovan@wildtrout.org

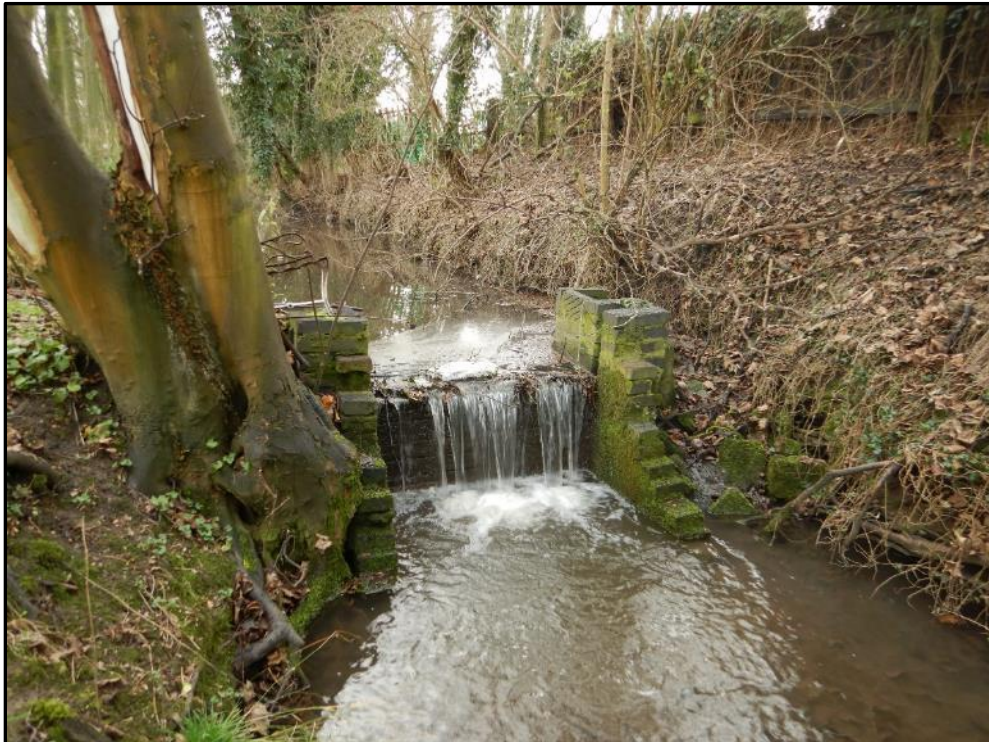
Pic 25 – A partially defunct structure that impounds the reach above it should be removed.

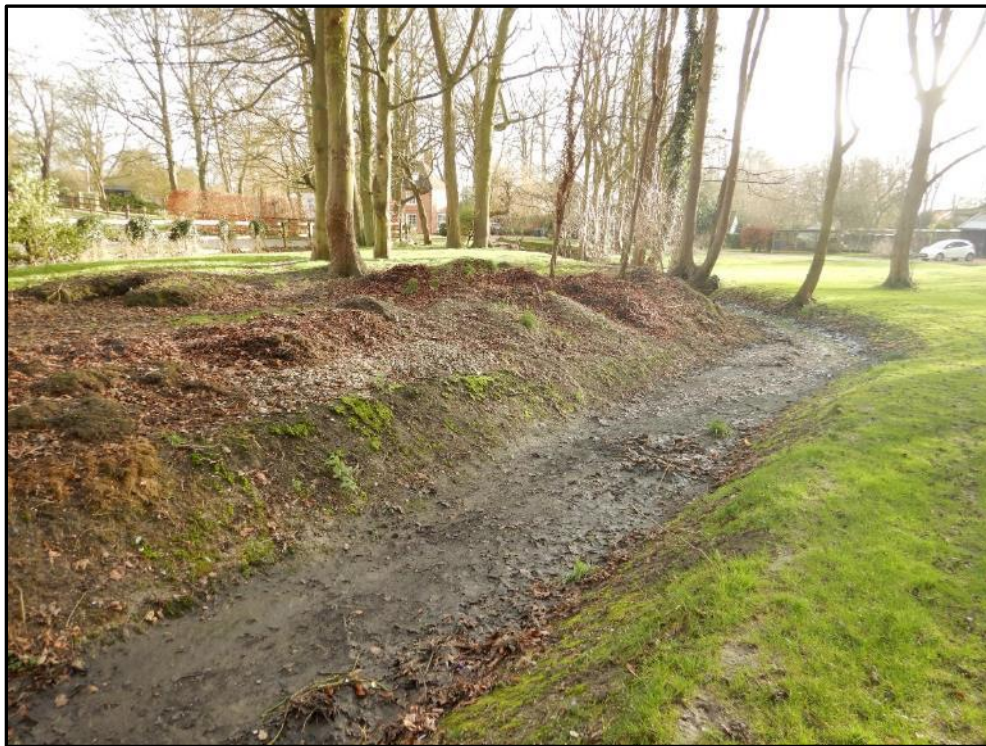
A channel was followed which led back to the mill. The channel was different in so far that it had a series of meanders, encouraging except for it being totally dry.

Pic 26 – The dry river channel emerging from the mill. The channel has clearly conveyed water in recent times, however the dark colouration is suggestive of road run-off. Note the large volume of leaves dumped on the bank top and slopes.

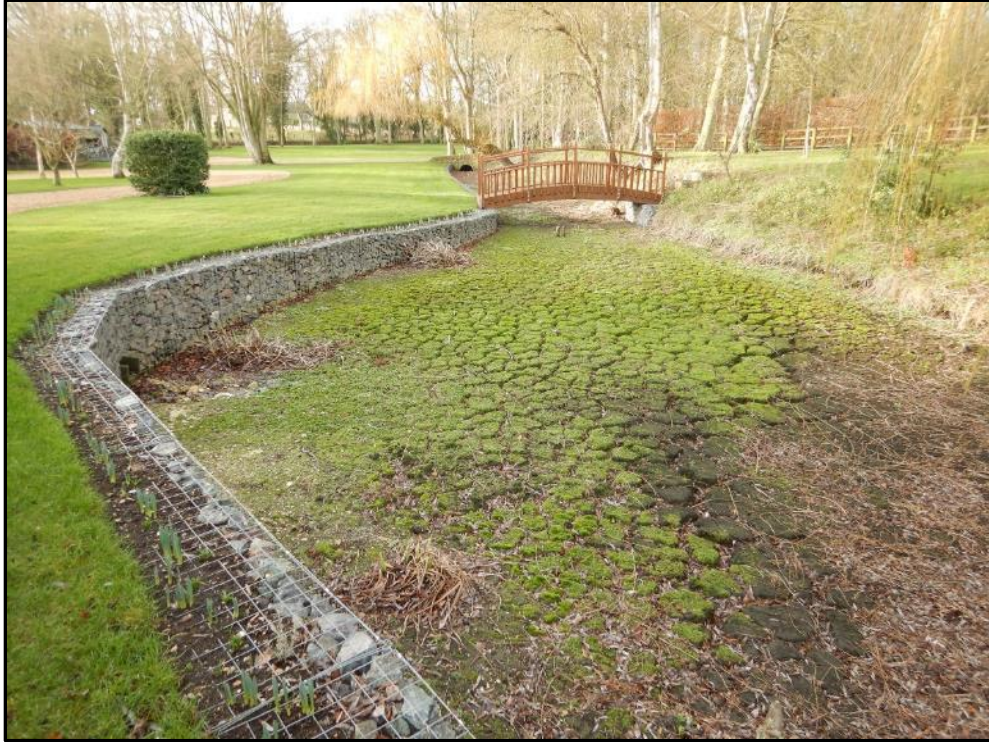
The former mill pool was also dry and retained a cracked-mud bed. Unfortunately, work has recently been undertaken to stabilise the bank using gabion cages filled with rock. This approach is more common for high energy rivers or motorway embankments, not dry chalk rivers. The potential for water vole habitat has been lost.

Pic 27 – The dry mill pool, even during the current wet period it holds no water.

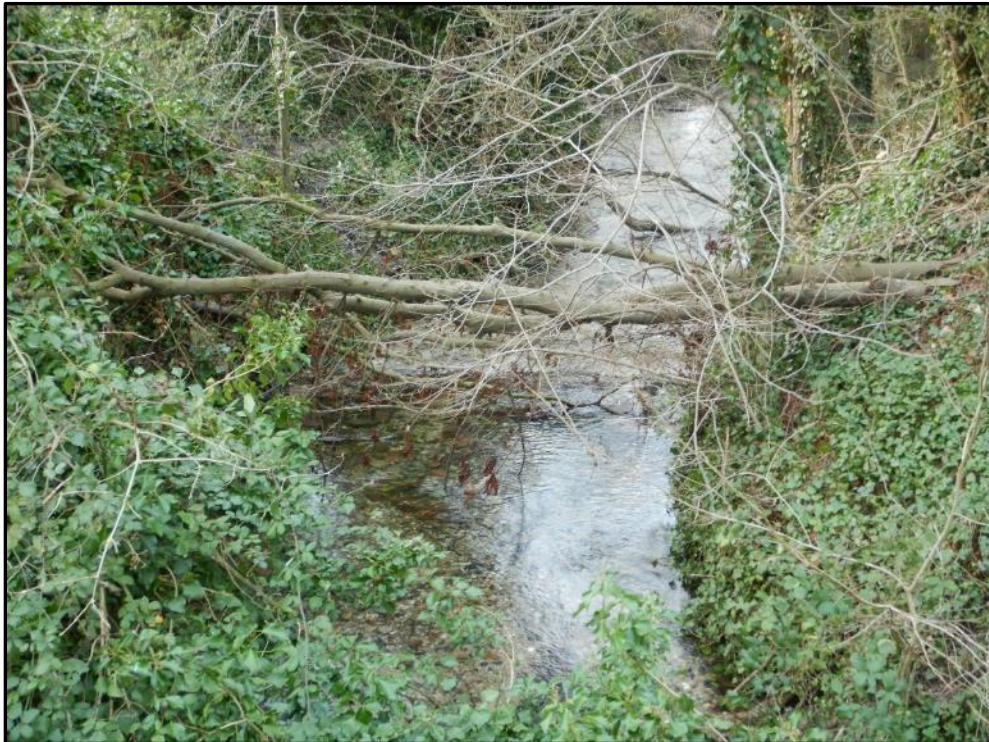
Pic 31 – The river looking downstream from Landwade Road (TL 62146 68439). Note the chalk and gravel beneath the scour caused by the fallen tree.

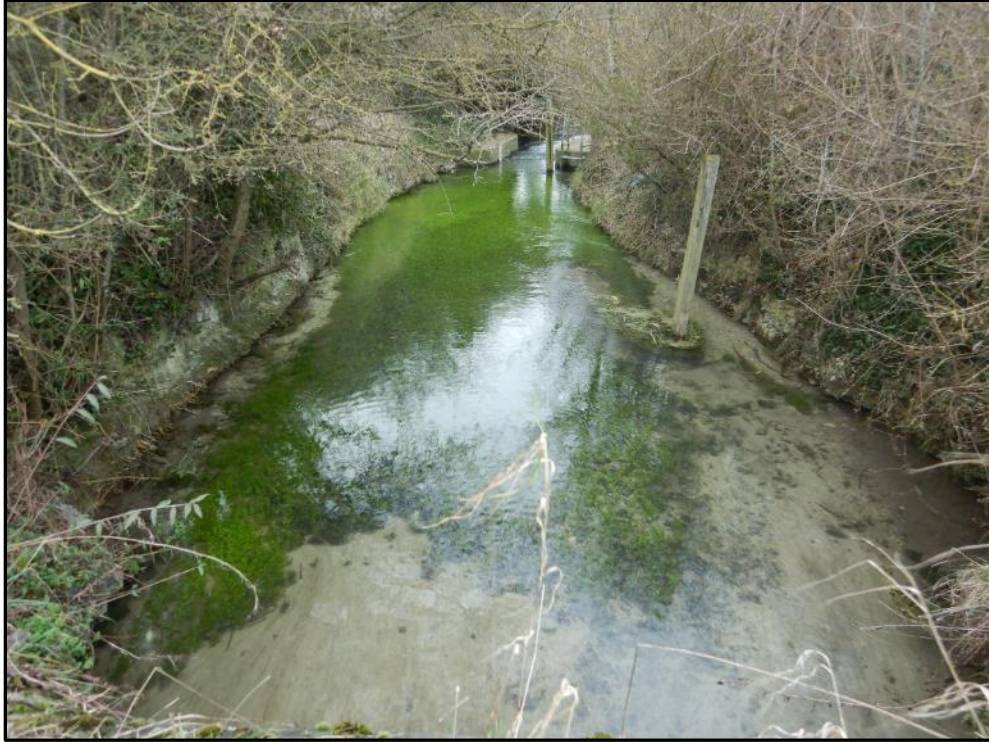
Pic 34 – The river looking downstream towards the EA gauging station (TL 60882 69562). Note the chalk particles smothering the bed and extensive growth of lesser water parsnip.

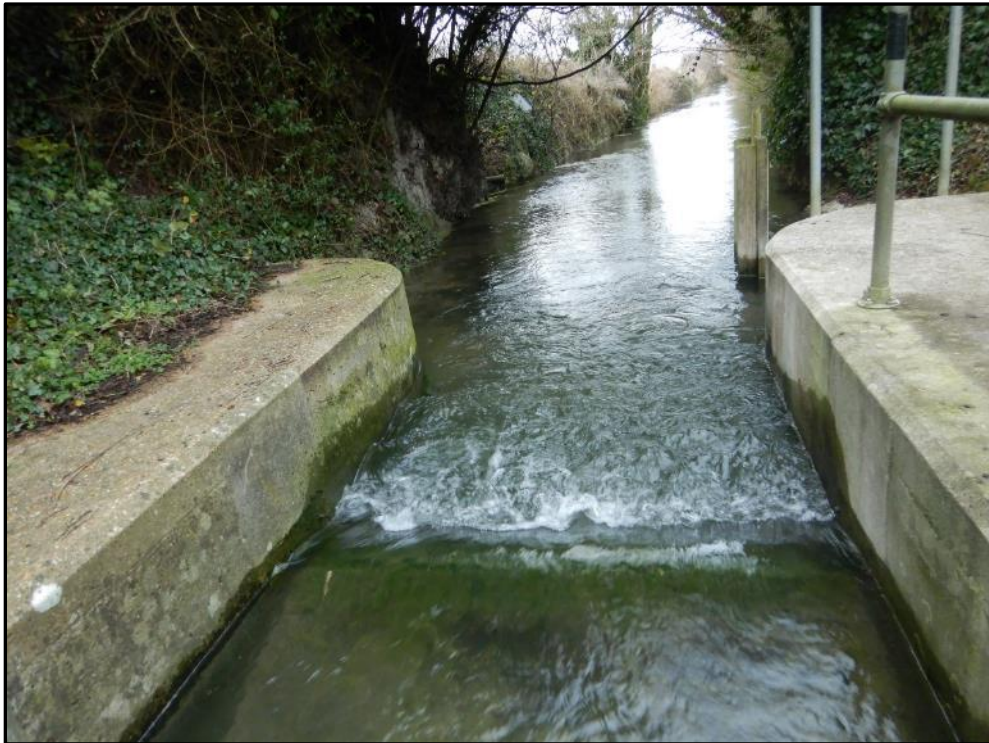
Pic 35 – The EA gauging station, a barrier to the upstream movement of small fish but adult trout would be able to traverse it (TL 60873 69589).

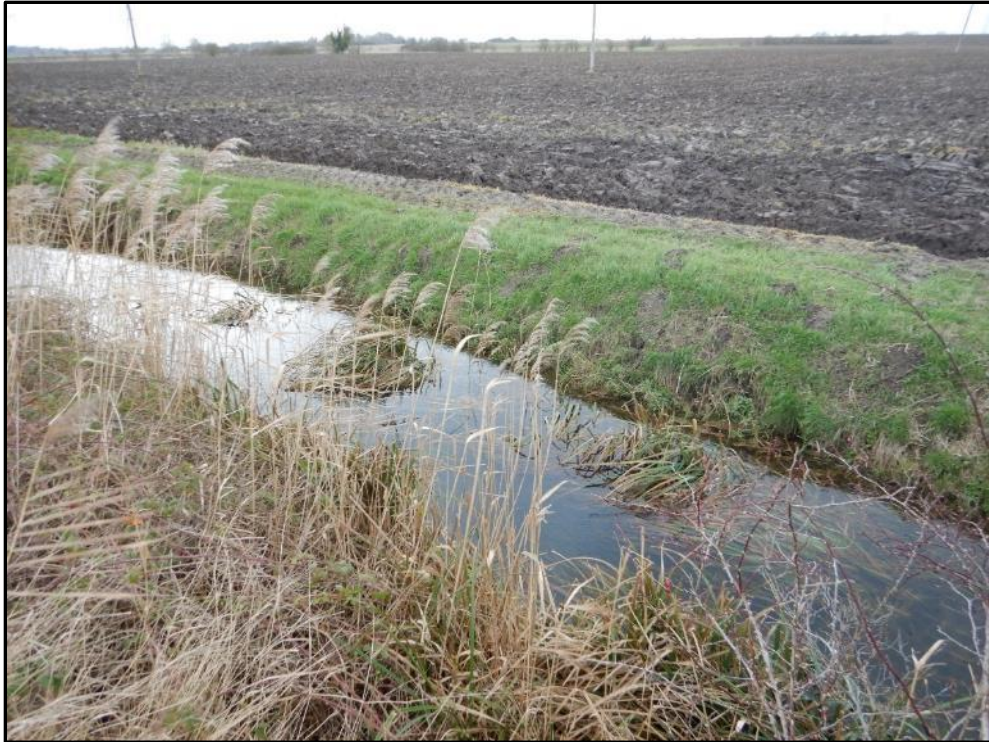
Pic 36 – The river beyond Nutt Tree Farm has taken on a fenland drain appearance (TL 58899 70014).
